Conservation Area Appraisal and
Management Plan
2012

TEVERSAL

I Executive Summary

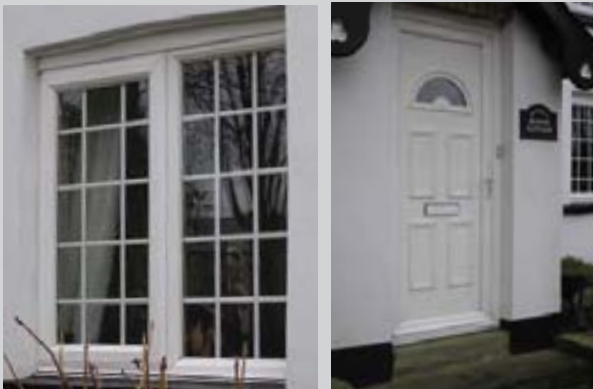
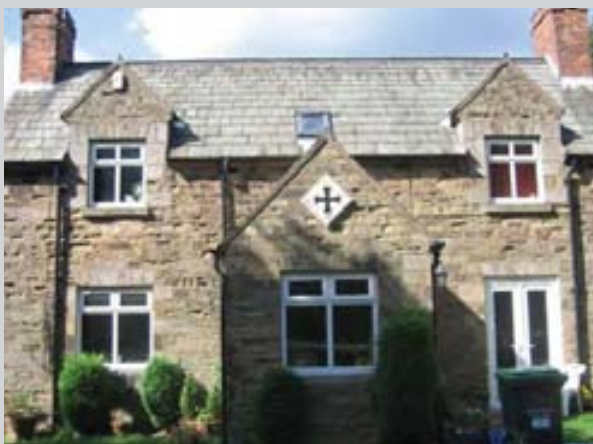
9.3.3.1 Timber is the traditional material for doors and windows on historic buildings within the Conservation Area. Other materials, include the non traditional UPVC replacements on many dwellings, which have adversely affected the architectural qualities of those properties. The glazing style of the windows is very much dependant on the age of the building and varies from side hung casements to vertical sliding sashes. Most of the more humble historic buildings had, and some retain, timber horizontal 'Yorkshire' sliding sash windows. Along with their slightly grander vertical sliding sashes these are of paramount significance and impact on the character of the historic buildings and village conservation area.

UPVC windows and doors in character properties. This should be discouraged in preference to traditional wooden framed windows and doors.

13.2.1 **Replacement Modern Materials:** The main threat to the character and appearance of the Conservation Area are the use of modern replacement windows and doors on both listed and unlisted historic buildings. These materials are becoming more prevalent and erode the character and appearance of the Conservation Area, particularly when they are inserted in one building where the others still retain their original windows and doors. A number of modern style timber doors and windows,

- 13.8.3 **Traditional Building Materials:** The use of traditional materials will be encouraged in new buildings and when repairs and extensions are made to existing buildings. Modern materials such as UPVC, varnish and aluminium should be avoided as these are out of character with the area and erode the quality of the street scene.

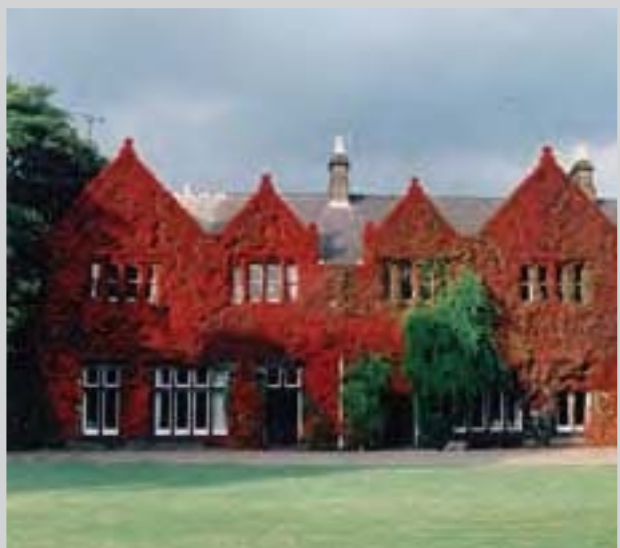
Holly and ivy have created a thick coverage on a number of walls in Teversal, including most of the south face of the Manor.

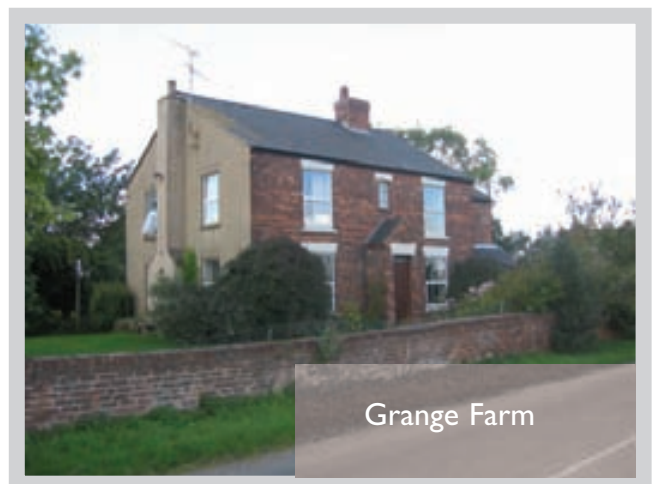
Grange Farm

11.1.12 Adjoining the farm buildings which are mentioned above is **Grange Farm** itself. This attractive two storey mid 19th Century building is mostly constructed from red brick. One side of the building has been rendered. The property is well enclosed, with a thick hedge separating the building from the road. The white gates, black drainpipe, guttering and eaves in addition to the wide variety of foliage in the gardens contribute further to the aesthetic appeal of the property and this area of the village. However, the modern windows detract from the character of this property.

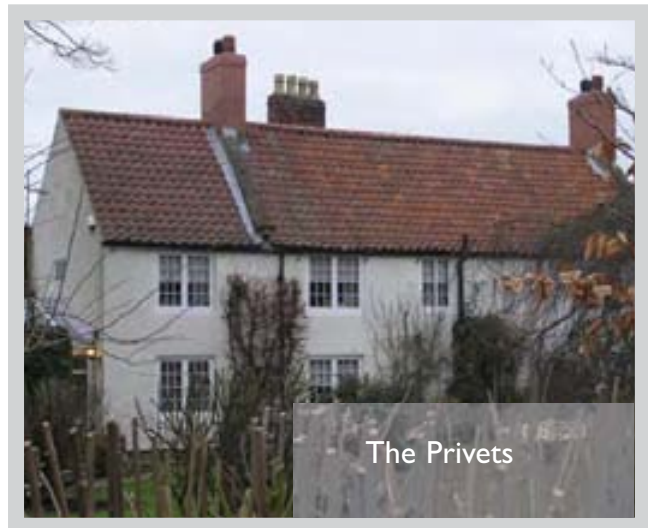
The Privets

11.3.11 Adjacent to Teversal Farm is an 18th Century Grade II Listed cottage by the name of **The Privets**. The cottage is rendered with dark red, gabled and lean to pan-tile roofs and ashlar stone dressings. The windows, which are Georgian in style and in-keeping with the character of the property, have recently been installed. The most recent addition to the property is a modern conservatory, fitted to the left hand side of the building. Despite this the cottage retains all the charm of a traditional country residence and makes a positive contribution to the historic streetscape of the Conservation Area. To the south is an orchard which provides many different varieties of tree and contributes to the significant natural beauty of this part of the village.

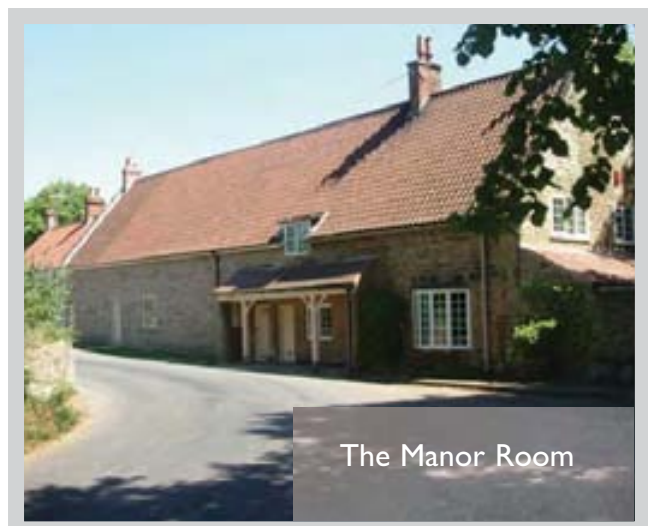
The Manor Room

11.3.12 Directly opposite The Privets is the **Manor Room**. Originally the property may have been a tithe barn, with a thatch or stone roof. In the 19th century it was converted to a school, with additions in the mid and late 19th Century. The building was affected during the past 50 years due to mining subsistence although this has been rectified by the recent refurbishment programme which was completed in 2006.

11.3.13 The building is directly on Buttery Lane and is dressed in stone, partly rendered with a steep pan tiled roof which is also a feature of the adjacent School House Cottage. It is single storey with attics throughout its length with the exception of the most northerly section of the Manor Room which are two storeys. The Yorkshire sliding sash windows are housed in 19th and 20th Century casements and the property is widely regarded as one of the most aesthetically pleasing buildings within the Conservation Area and now also one of the most important for the community since the refurbishment of the Manor Room has ensured that community events can once again take place. The building is a prime example of

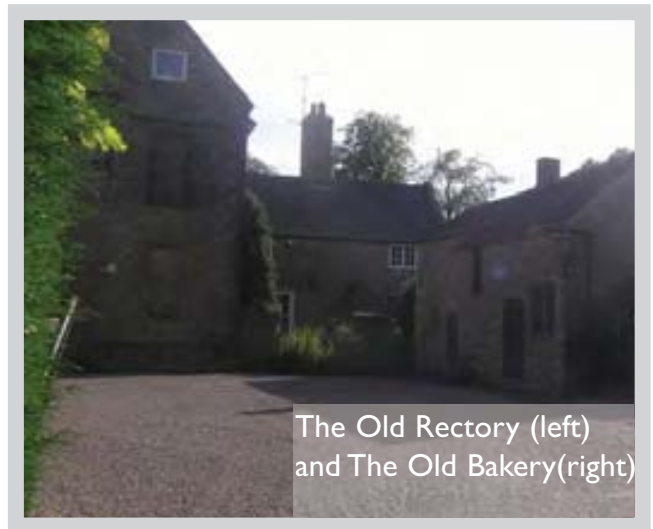
11.3.30 Both **The Old Rectory** and the high garden wall which adjoins it are Grade II listed and date from around the late 17th Century, the entry possessing an impressive set of tall gate piers. The property was refenestrated and additions to the building were added in the mid 19th Century. A relatively humble property, it lacks the more extravagant details of some other buildings in the village such as the Manor. However despite this, it possesses its own unique character and contributes significantly to the historical interest of the Conservation Area, having served as the vicarage for many years. In more recent years it has served as a residential property when the rector moved to the parsonage, which is outside the Conservation Area. The building is constructed of coursed and squared rubble, partly rendered, with slate roofs and possesses mainly 19th Century sash windows with cornices. The 20th Century porch to the right of the building (when viewed from the front) is obscured from this angle by foliage and so the overall architecture and character of the building is comparatively well preserved.

11.3.31 The **Old Bakery** is also Grade II listed but is very different architecturally from the Rectory. Despite this the building retains much of its original charm and character. The single range but now two storey property dates from the late 17th Century and mid 19th Century and like many properties in the eastern area of the village is constructed of coursed and squared rubble with red pan-tile roof. The windows are mainly late 19th Century casements. The dwellings appeal is heightened by the variety of foliage in the garden and the ivy covered wall and gate piers. Despite the creation of skylights in the roof the building contributes to the historic and architectural character of the conservation area.

The Old Rectory (left)
and The Old Bakery(right)
